# Industrial machining of Douglas fir with various tools and materials

G. Goli <sup>(1)</sup>, R. Marchal <sup>(2)</sup>, M. Negri <sup>(3)</sup>

## Abstract

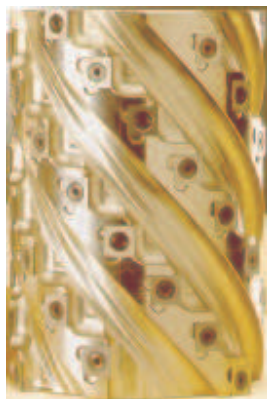
Figure 1 - Carbide tipped knives on the special helicoidal cutter head

1. planing process with planing machine (characteristics: i) r.p.m. 6500; ii) feeding speed 10 and 15 m/min.) provided with carbide tipped knives on a special helicoidal cutter head, as in Figure 1;
2. spindle shaping process with shaping machine (characteristics: i) r.p.m. 6500; ii) feeding speed 10 m/min.) provided with carbide tipped moulding tools;
3. spindle shaping process with shaping machine (characteristics: i) r.p.m. 6500; ii) feeding speed 10 m/min.) provided with Polycrystalline Diamond (PCD) moulding tools.

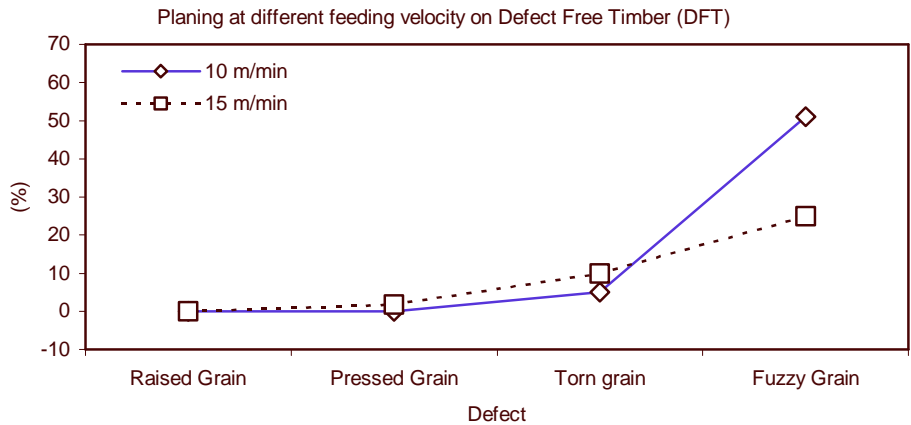
Figure 3 - Planing process performed by using carbide tipped knives on a helicoidal cutter head at different feeding velocities on Defect-Free Timber. On Y axis the incidence (%) of the various defects from fair to very poor quality (grade from 3 to 5) is reported

In Figure 3 the planing process performed through carbide tipped knives on a helicoidal cutter head are reported at different feeding velocities on Defect-Free Timber. In Figure 4 the same process was checked on Timber with Defects. For both charts on the Y axis the incidence (%) of the various defects from fair to very poor quality (grade from 3 to 5) is reported. The tests of spindle shaping process were performed by using both carbide tipped and Polycrystalline Diamond moulding tools and the grading process was carried out on surfaces without wood defects (Defect-Free Timber) in order to point out the properties of Douglas fir timber towards these machining processes.

As shown in Figure 3, a different feeding velocity on Defect-Free Timber provided similar behaviour: no significant incidence for raised, pressed and torn grain; fuzzy grain appears at 15 m/min and its occurrence increases at 10 m/min feeding velocity.

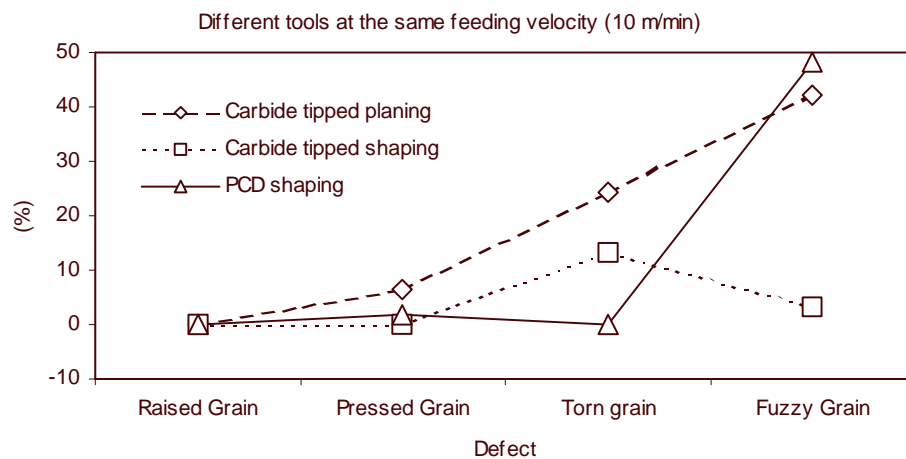
Figure 5 - Planing and shaping processes performed respectively with carbide tipped knives on a helicoidal cutter head and with moulding tools (both carbide tipped and PCD) at the same feeding velocity on Defect-Free Timber. On the Y axis the incidence (%) of the various defects from fair to very poor quality (grade from 3 to 5) is reported

In Table 4 both planing and shaping processes are shown towards the occurrence of faces with any defect due to the machining process and the occurrence of faces providing machining defects. In Figure 5 planing and shaping processes performed respectively with carbide tipped knives on a helicoidal cutter head and with moulding tools (both carbide tipped and PCD) at the same feeding velocity were observed on Defect-Free Timber.

Figure 5 points out the main defects of each type of process/tool combination, at the same given conditions mentioned above:

- raised and pressed grains were never relevant;
- torn grain was relevant by machining with carbide tipped tools both by planing and spindle shaping;
- fuzzy grain heavily affected both specimens planed by carbide tipped tools and specimens spindle shaped by PCD tools.
